2017 DIRT Report Version 11.0

National Report on Damage to Underground Infrastructure

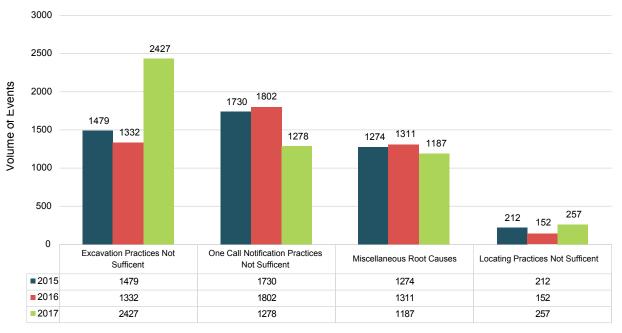
Figure 9: Facility Events by One Call Notification Practices Not Sufficient

Figure 9 illustrates a breakdown of the Root Cause subcategories for One Call Notification Practices Not Sufficient. This figure illustrates the need to continuously increase excavator and general public awareness about calling to request a locate before digging starts. There has been a significant drop in Notification to One Call Centre Made but Not Sufficient. This subcategory includes instances such as inadequate information or not allowing sufficient lead times for a locate request.

This is a major category leading to events as seen in (Figure 8) and broken out in (Figure 9). Of the 4597 events reported in 2016, 1195 or 26% were due to no notification being made to Ontario One Call.

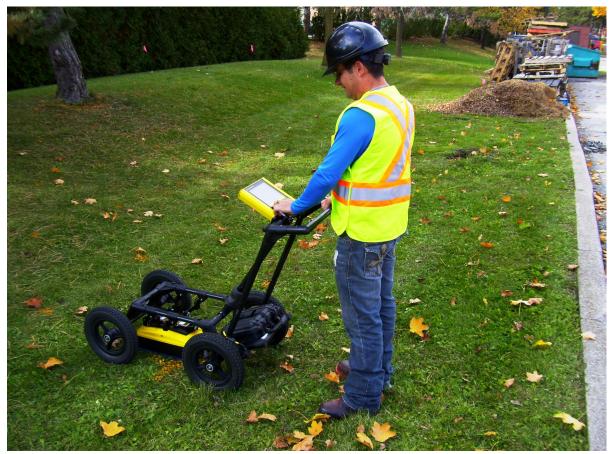
It's important to have a general understanding of locating technology so that you'll know which one to apply to your specific project. GPR, pictured here, is ideal for locating non-conductive buried assets such as clay and PVC pipes.
