2019 DIRT Report

Ver 13.0

The Ontario Regional Common Ground Alliance (ORCGA) has been collecting underground damage data since 2005 to better understand the root causes that lead to these events and to develop and target public awareness plans to minimize the risk of future events.

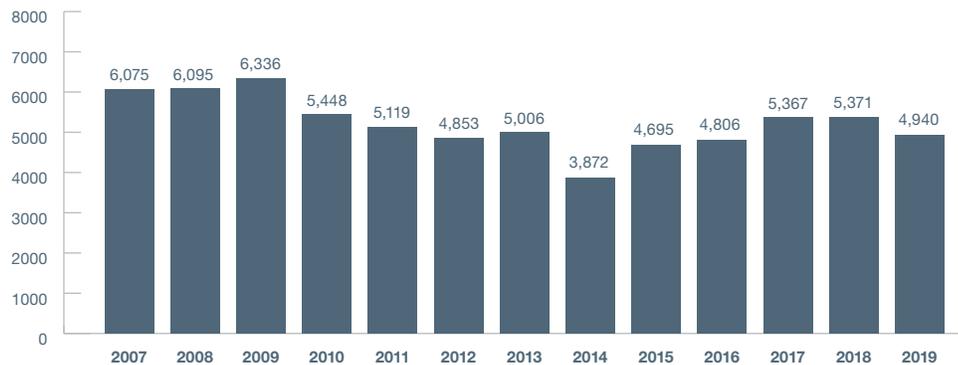
Figure 1: Facility Events Submitted by Year

In 2019, facility events saw an overall decrease of 8% over 2018. We will break out incidents to gain insight on where attention and efforts are to be made to continue reducing damages in the future.

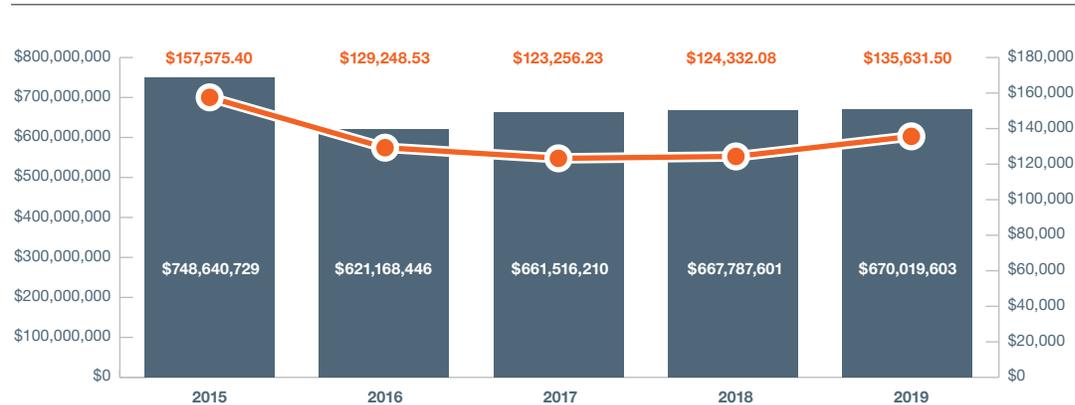
Figure 2: Socio-Economic Cost of Incidents

In 2019, Socio-Economic cost the province of Ontario a total \$670M+, and the average cost per incident totalled \$135K.

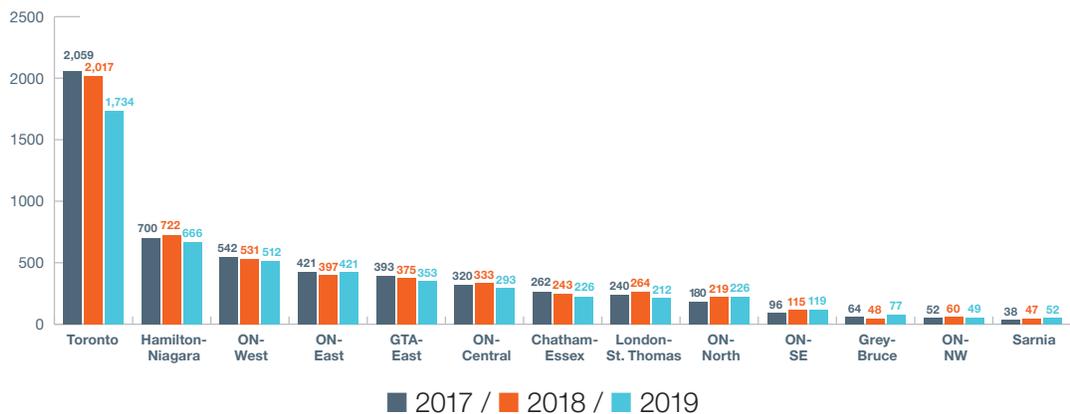
Figure 3: Volume of Events Submitted Per Geographic Area

Figure 3 illustrates the number of events for each geographic area over the past three years. While there have been fluctuations, the majority of Geographic Councils are seeing a downward trend in events. On a positive note, Toronto's incidents continue to show a downward trend by 14%. The increase in the ON North area could be attributed to increased capital projects for pipeline and Fibre to the Home.

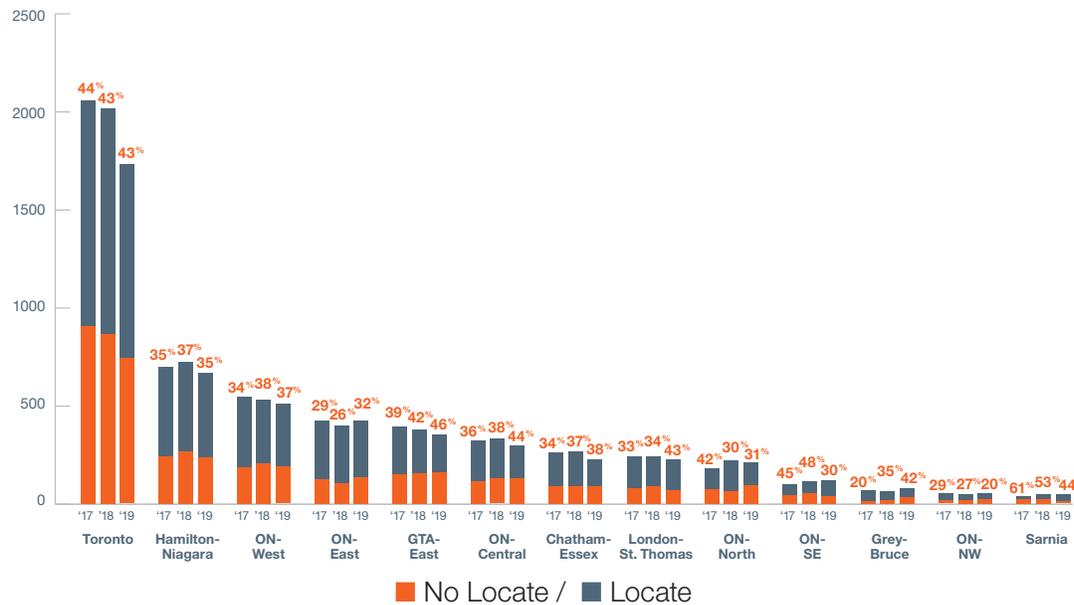
Figure 4: Locate Versus No Locate Events by Geographic Area

Figure 4 illustrates the number of events in 2019 where Ontario One Call was notified for a locate request versus not being notified for a locate request, broken down by geographic area.

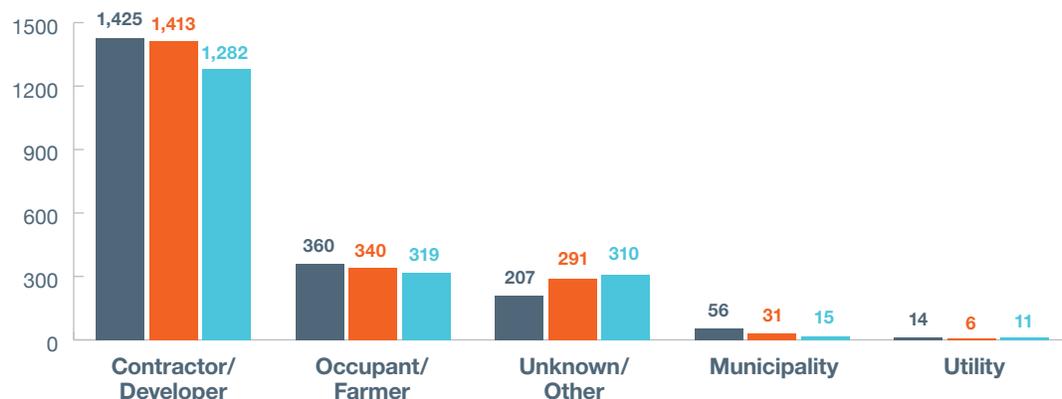
Figure 5: No Locate Damages by Excavator Type | 2017 / 2018 / 2019

Figure 5 provides further analysis on the categories of excavators that are not submitting locate requests.

Increased education should be targeted towards the Contractor/Developer who were responsible for 66% of the no locate damages in 2019.

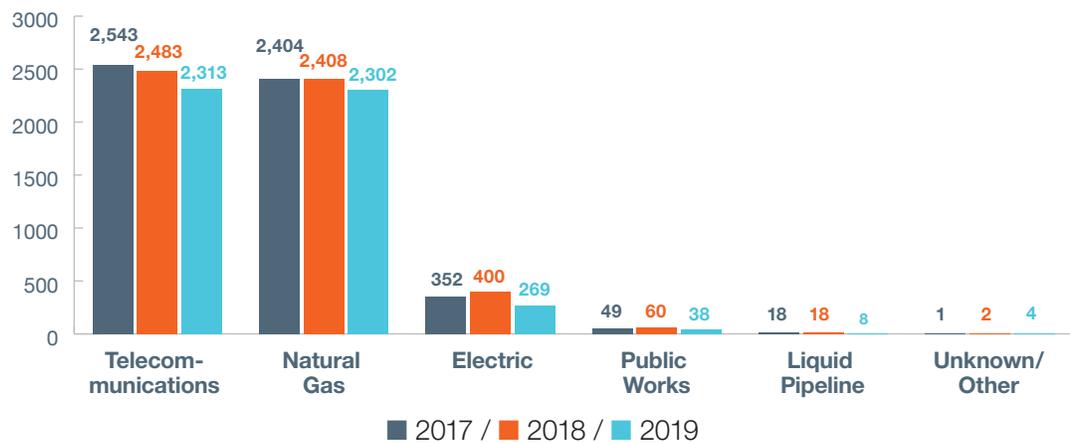
Figure 6: Facility Events Submitted by Stakeholder Group

Figure 6 illustrates a distribution of events by stakeholder group for the past three years. Telecommunications and Natural Gas continue to submit the highest volume of events. In order to support future trend analysis, additional stakeholders are encouraged to submit their events into DIRT.

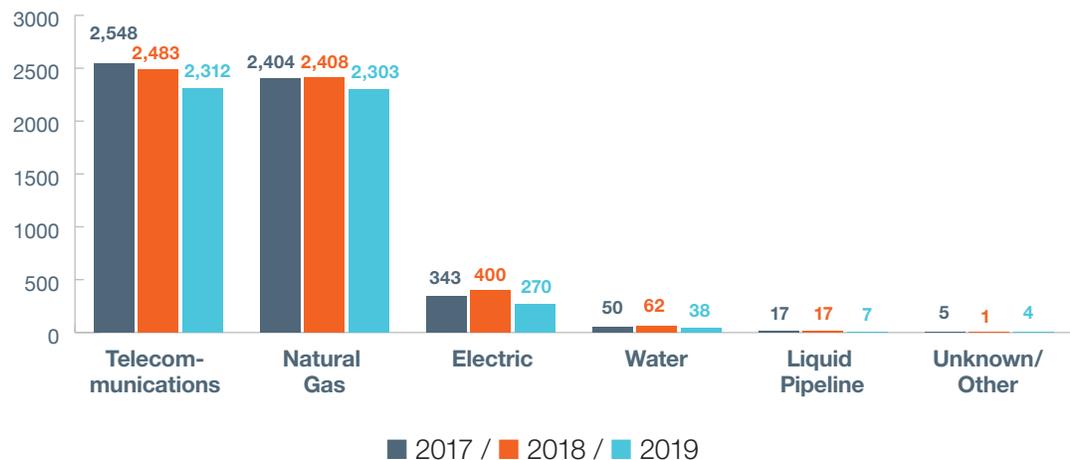
Figure 7: Submitted Facility Events by Type of Facility Affected

Figure 7 illustrates that Telecommunications and Natural Gas continue to be the primary facilities affected by events reported in DIRT. This aligns with the high volume of events that the Stakeholders continue to submit.

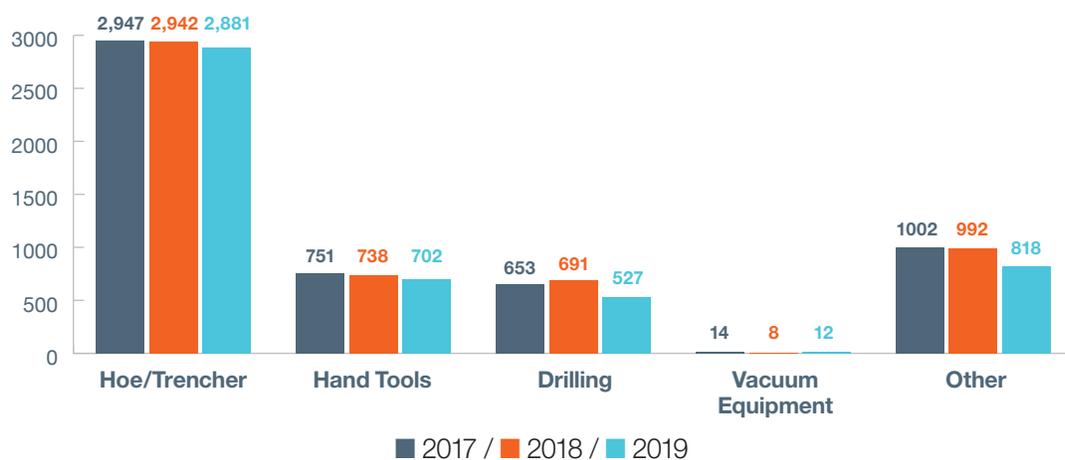
Figure 8: Submitted Facility Events by Excavation Equipment Group

Figure 8 illustrates a distribution of events caused by various groups of excavation equipment. In 2019 the Hoe/Trencher group continued to account for the largest volume of events. Submitters are encouraged to minimize listing equipment as 'other' in order to improve data accuracy.

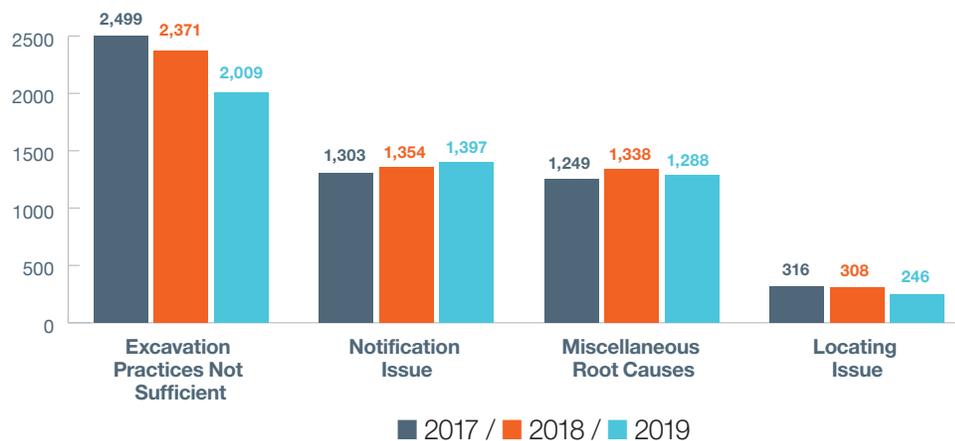
Figure 9: Facility Events by Root Cause Category

Figure 9 illustrates the distribution of events by Root Cause category. The most common causes of events are a result of Excavation Practices Not Sufficient. Although there has been a significant decrease in this category, emphasis should be made to continue to reduce events by providing targeted outreach and education to the excavator community.

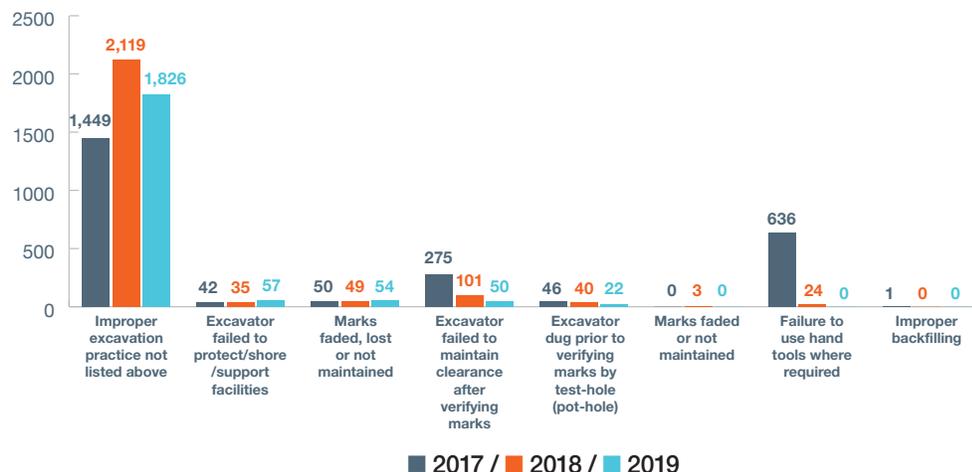
Figure 10: Facility Events by Excavation Practices Not Sufficient

Figure 10 illustrates a 3 year breakdown of the Root Cause subcategories for Excavation Practices Not Sufficient. As seen below, Improper Excavation Practice Not Listed Above continues to be one of main issues. This Root Cause subcategory is defined as any other excavator error, which cannot be classified as one of the other six Root Cause subcategories within Excavation Practices Not Sufficient.

The next highest Root Cause subcategory is the failure to Protect/Shore/Support Facilities.

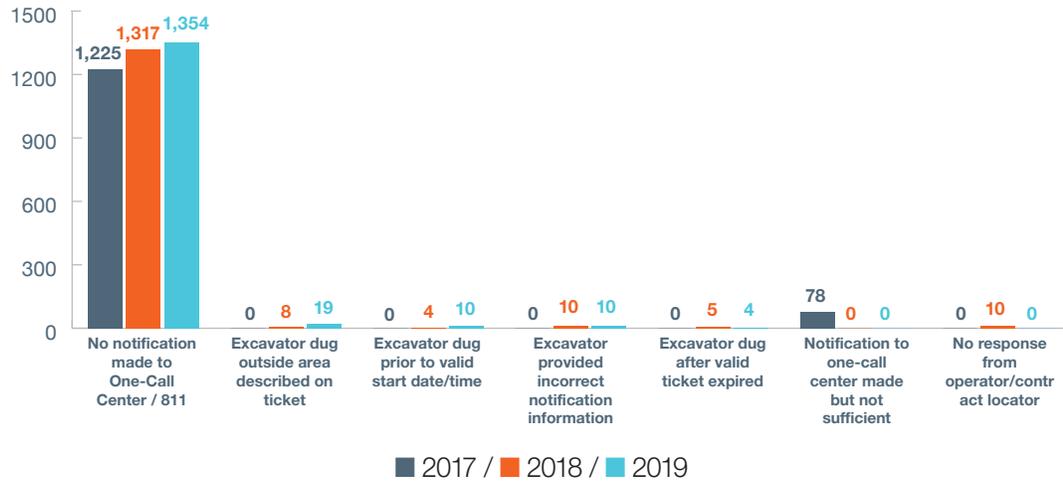
Figure 11: Facility Events by Notification Issues

Figure 11 illustrates a three year breakdown of the Root Cause subcategories for Notification Issues.

This figure illustrates the need to continuously increase excavator and general public awareness about requesting a locate before digging starts, as this number continues to increase.

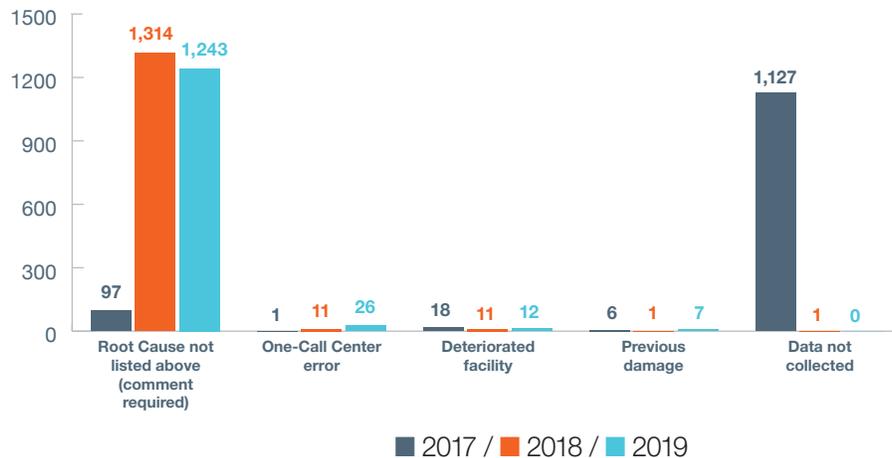
Figure 12: Facility Events by Miscellaneous Root Causes

Figure 12 illustrates a three year breakdown of the Root Cause subcategories for Miscellaneous Root Causes.

The most prevalent Root Cause subcategory is Root Cause Not Listed Above, which in previous years was listed as Data Not Collected. Data Not Collected is not an option in the new DIRT data format.

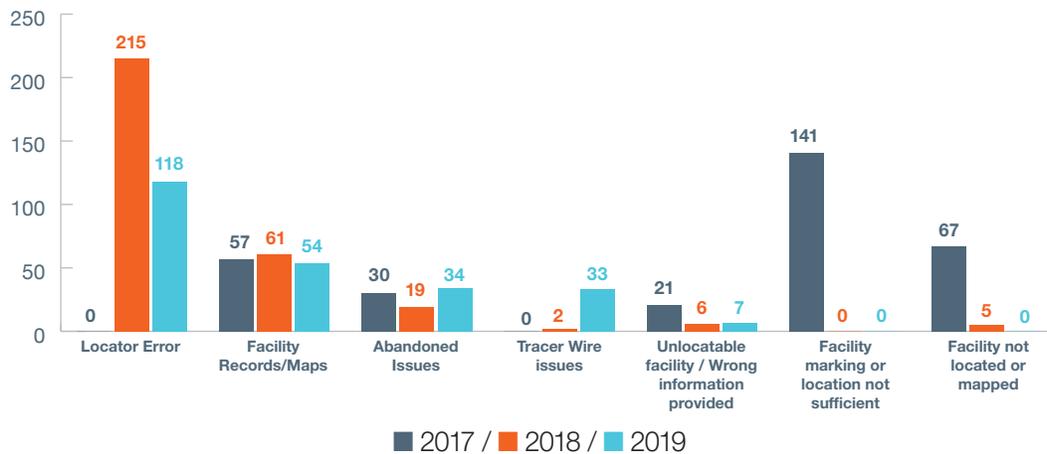
Figure 13: Facility Events by Locating Issues

Figure 13 illustrates a three year breakdown of the Root Cause subcategories for Facility Events by Locating Issues. These subcategories were the most affected in the 2018 update of the DIRT Report with new subcategories added, as well as drill down of the old categories.

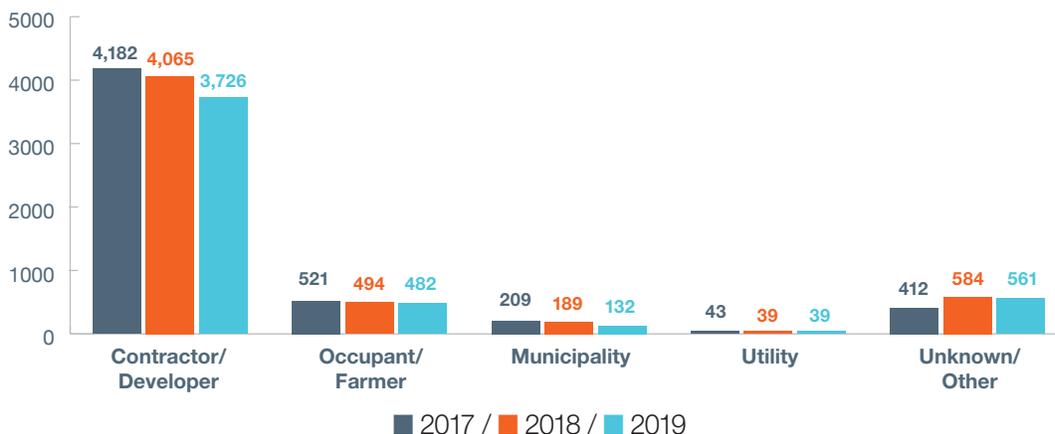
Figure 14: Facility Events by Type of Excavator

Figure 14 illustrates the distribution of events by Type of Excavator showing that Contractor/Developer continues to be involved in the majority of reported events, although there has been a downward trend since 2017.

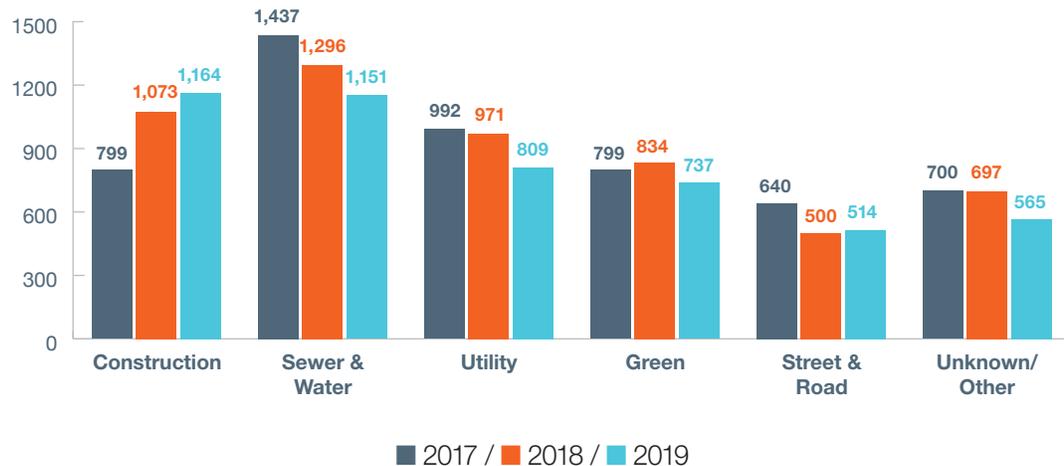
Figure 15: Facility Events by Type of Work Performed

Figure 15 illustrates a distribution of events by Type of Work Performed. Construction continues to be a concern as the volume of events have shown a significant increase for the past two years. Construction has now become the primary type of work causing events. Sewer and Water has seen a significant reduction from 2017 to 2019.

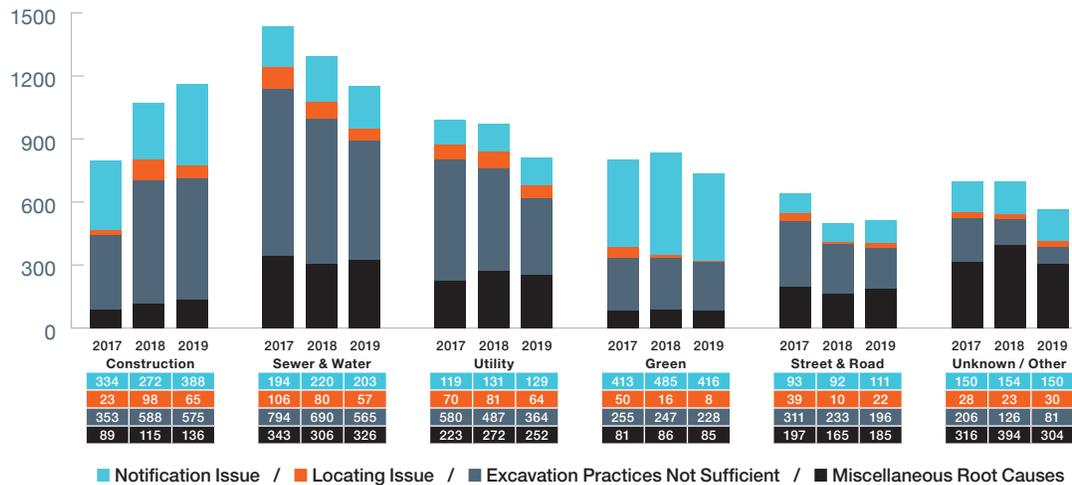
Figure 16: Facility Events by Root Cause Group and Industry

The following charts illustrate the known Root Causes of events for the six work groups of Construction, Sewer and Water, Utility, Green, Unknown/Other and Street & Road Work for 2017, 2018 and 2019.

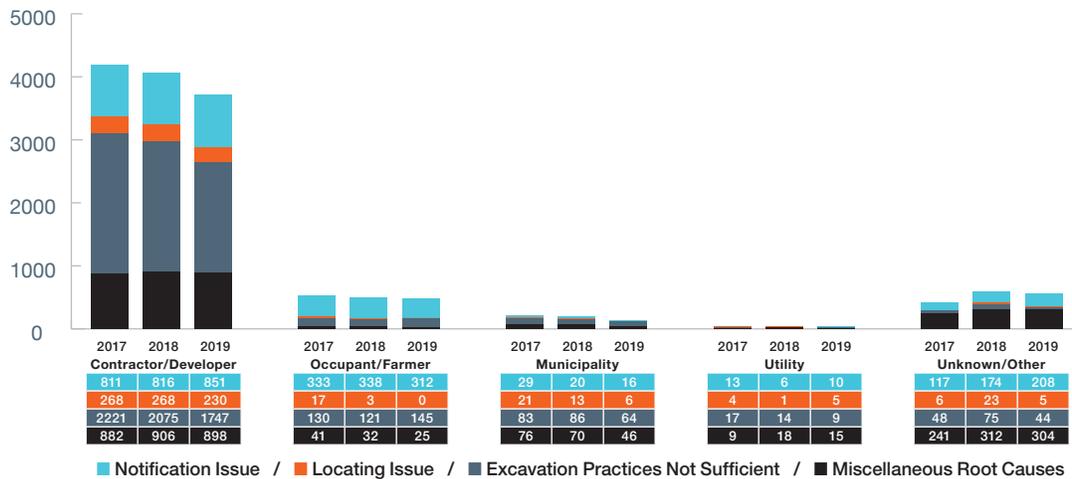
Figure 17: Facility Events by Root Cause Category and Excavator Type

Figure 17 illustrates that the Contractor/Developer excavator type continues to represent the majority of events submitted under the Excavation Practices Not Sufficient category, and has seen a decrease in 2019.

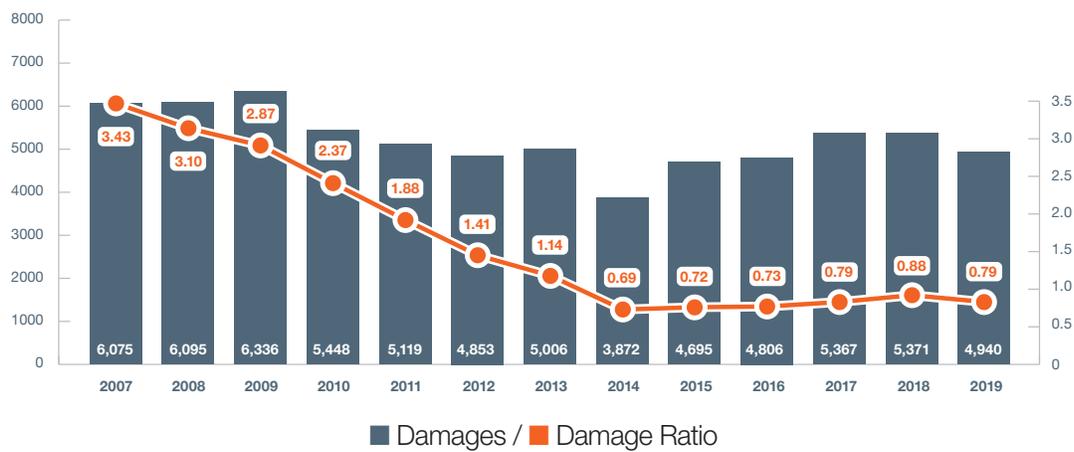
Figure 18: Damage Ratio - Damages/1000 Notifications

Figure 18 illustrates the damage ratio relative to the volume of events over the past 13 years. Industry practice is to measure damage prevention performance by the volume of damages per thousand notifications.

Due to a change in Ontario One Call process in 2018, notifications have decreased which negatively affects the Damage Ratio.

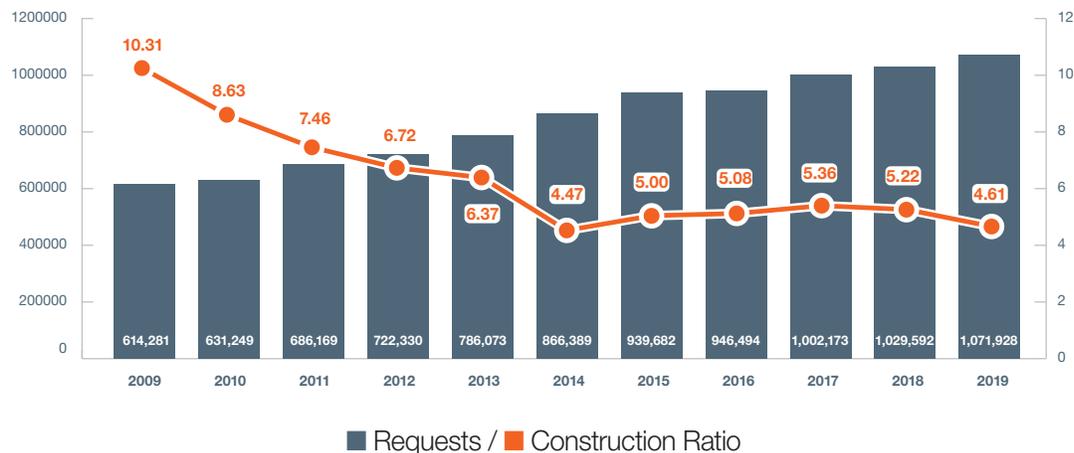
Figure 19: Damages/1000 Requests

In response to the Ontario One Call process changes, this new chart was created to show damages per 1000 requests as this has remained consistent and is driven by either public awareness or economic events.

Figure 19 illustrates that the 2018 Damage to Request ratio saw a decrease, reversing an upward trend from 2014. This trend continues in 2019.

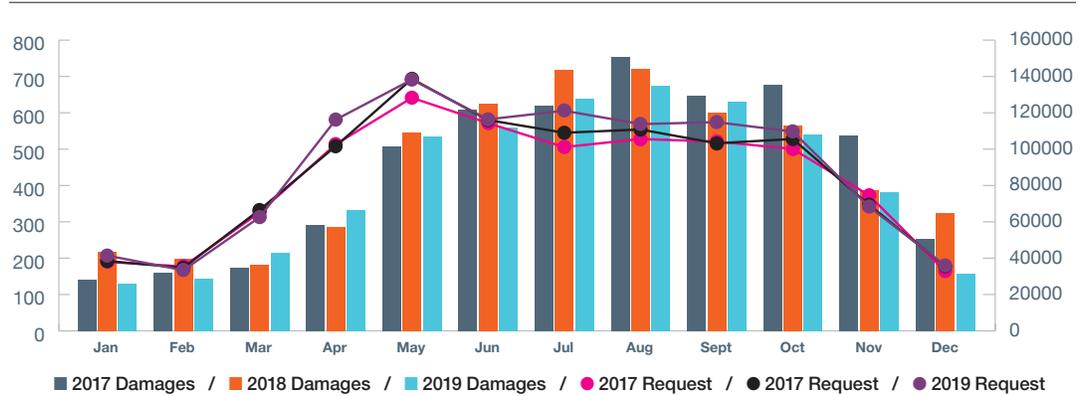
Figure 20: Damages by Month

Figure 20 shows that although the peak of locate requests happen in May, the peak of damage incidents occur in August.

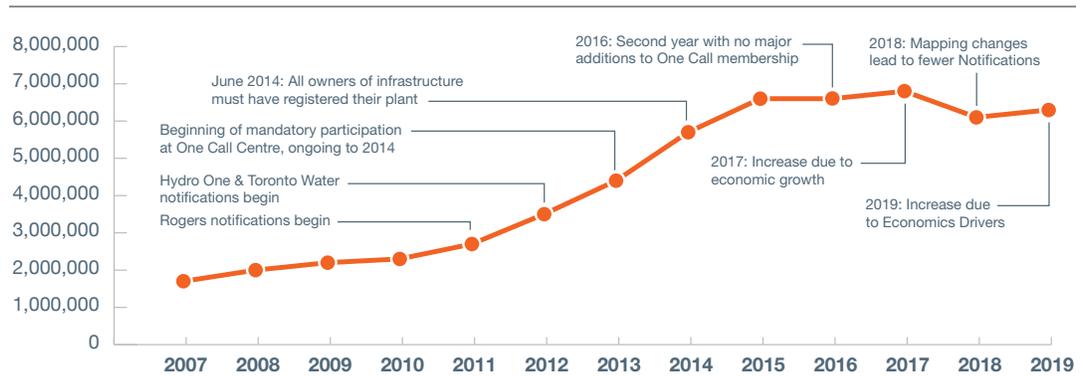
Figure 21: History of Notifications

Figure 21 demonstrates that up until 2015, notifications rose significantly as major stakeholders became members of Ontario One Call.

Any further changes would be due to outside economic events.
