2017 DIRT Report Version 11.0

ORCGA
Common Ground Alliance

The Damage Information Reporting Tool (DIRT) is the result of the efforts made by the ORCGA to gather meaningful data about the occurrence of facility events. An “event” is defined by the DIRT User’s Guide as “the occurrence of downtime, damages, and near misses.” Gathering information about these types of events give the ORCGA the opportunity to analyze the contributing factors and recurring trends. This allows the ORCGA to identify potential educational opportunities to meet our overall goals of reducing damages and increasing safety for all stakeholders.

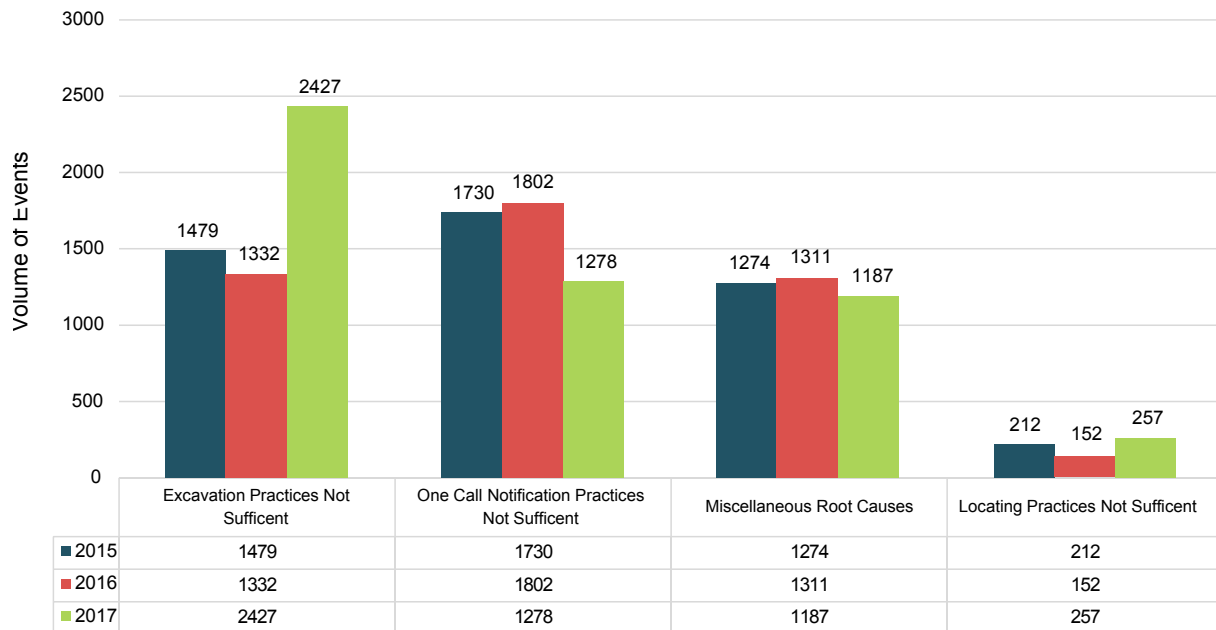
Figure 8: Facility Events by Root Cause Category

Figure 8 illustrates the distribution of events by Root Cause category. The most common identified causes of events are a result of Excavation Practices Not Sufficient, One Call Notification Practices Not Sufficient and Miscellaneous Root Causes.

This is a major category leading to events as seen in (Figure 8) and broken out in (Figure 9). Of the 4597 events reported in 2016, 1195 or 26% were due to no notification being made to Ontario One Call.

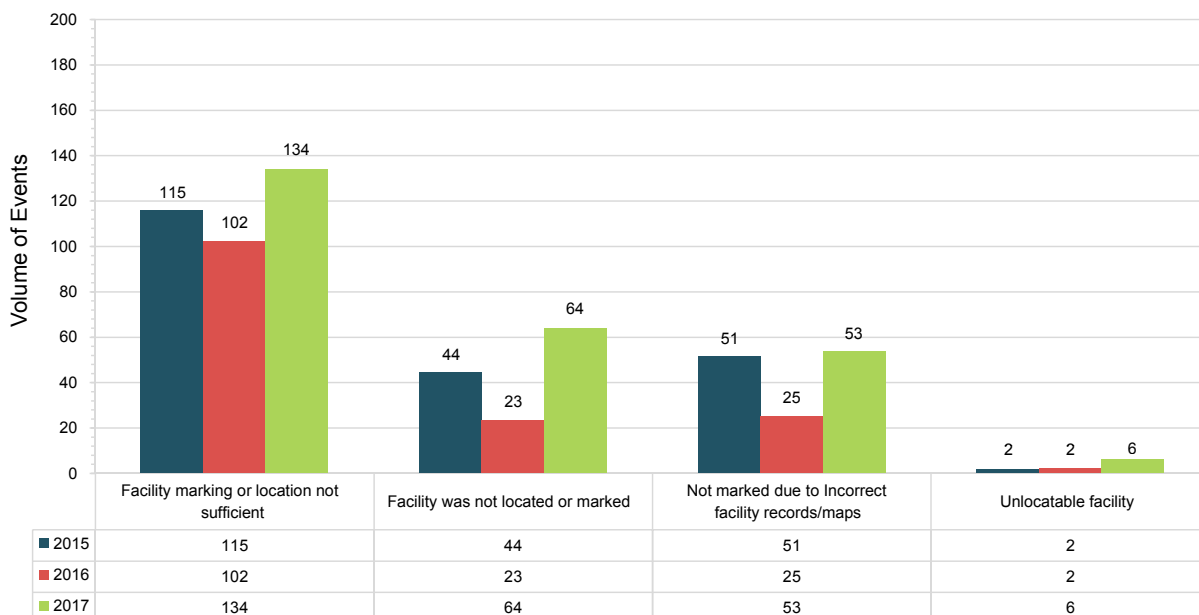
Figure 11: Facility Events by Locating Practices Not Sufficient

Figure 11 illustrates a breakdown of the Root Cause subcategories for Locating Practices Not Sufficient for the past three years. The most prevalent Root Cause subcategory is Facility Marking or Location Not Sufficient. Refer to Root Tip Card (Appendix B) for examples of Facility Marking or Location Not Sufficient events.

2017 has seen a significant increase across all categories.

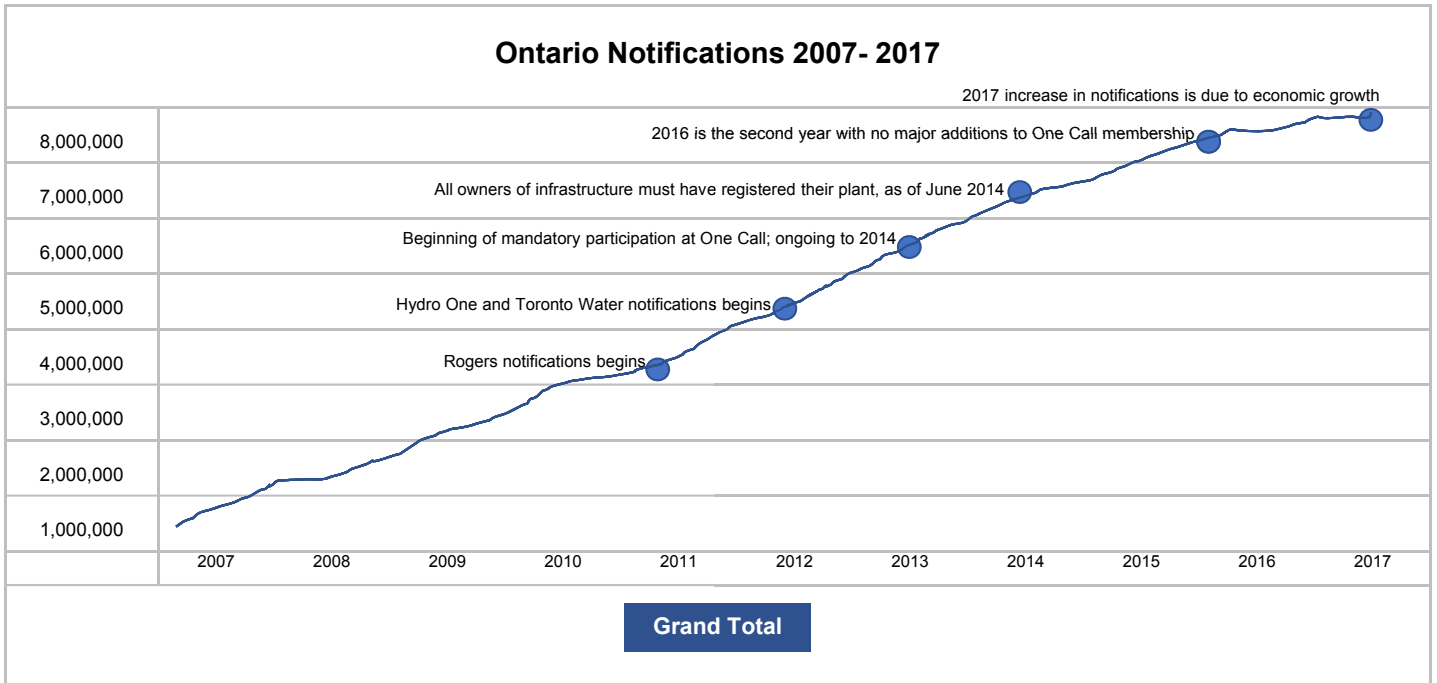
Figure 18: History of Notifications

This graph demonstrates that up until 2015, notifications rose significantly as major stakeholders became members of Ontario One Call.

Any further changes would be due to outside economic events.

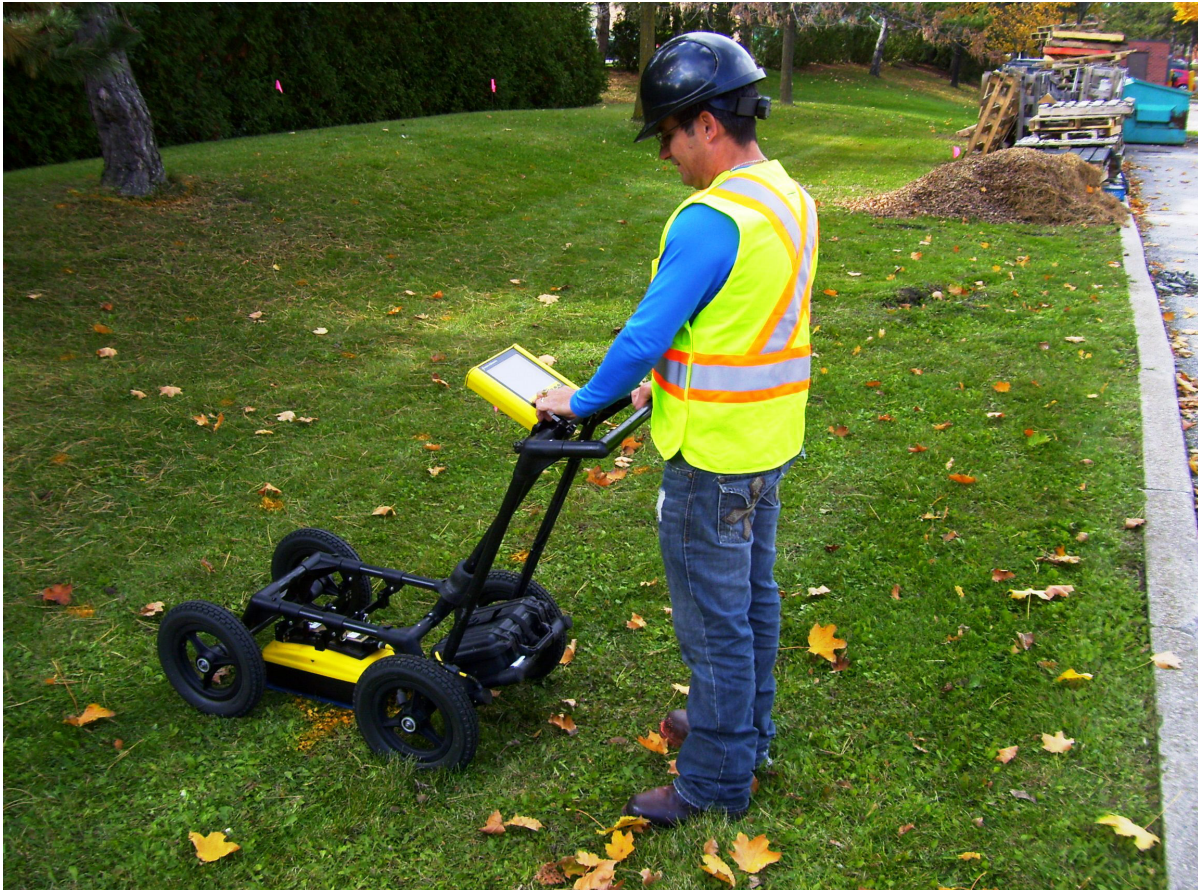
It's important to have a general understanding of locating technology so that you'll know which one to apply to your specific project. GPR, pictured here, is ideal for locating non-conductive buried assets such as clay and PVC pipes.
