# 2018 DIRT Report

Ontario Regional  
**ORCGA**  
Common Ground Alliance

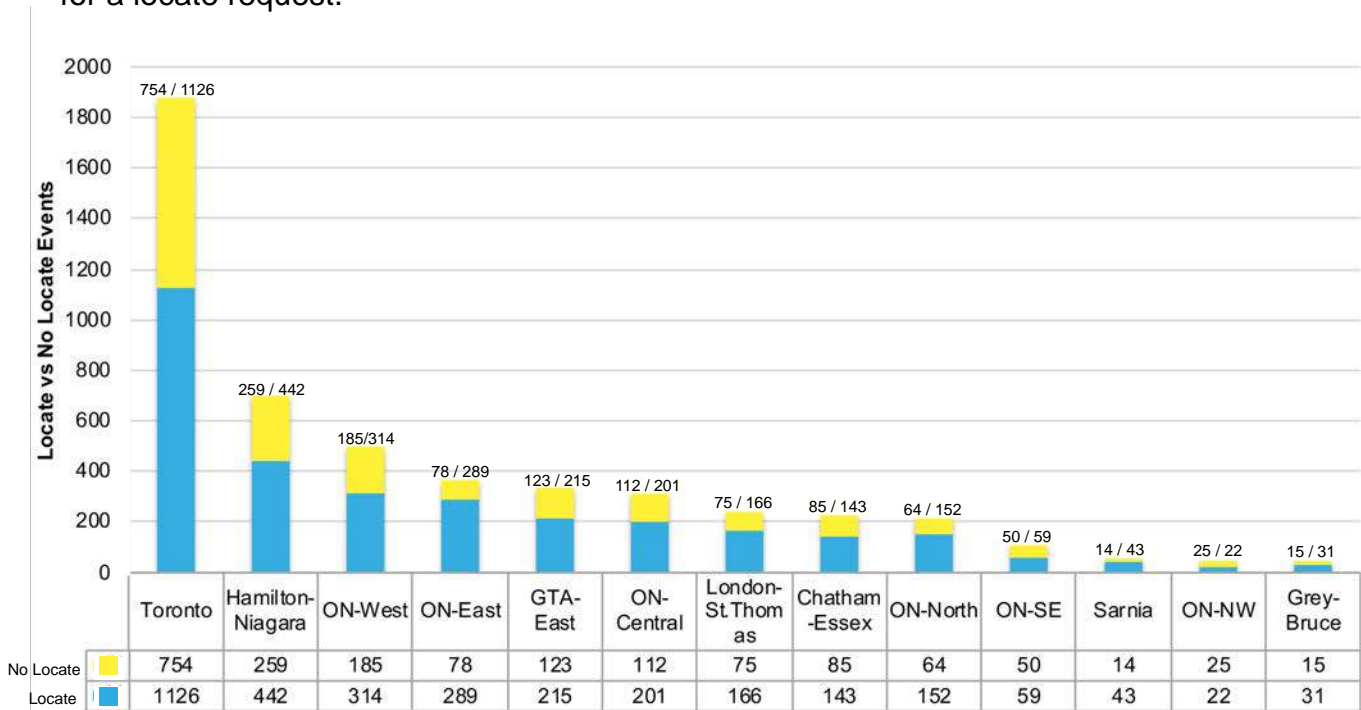
**Figure 3: Locate Versus No Locate Events by Geographic Area**

Figure 3 illustrates a distribution by geographic area comparing the number of events in 2018 where Ontario One Call was notified for a locate request versus not being notified for a locate request.

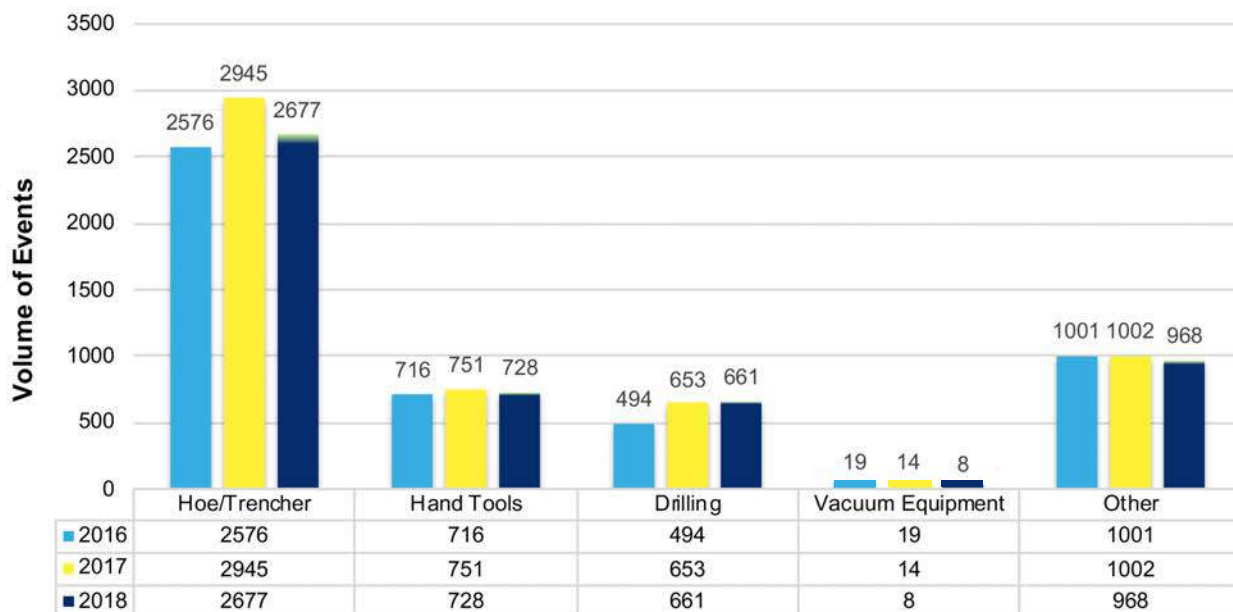
**Figure 7: Submitted Facility Events by Excavation Equipment Group**

Figure 7 illustrates a distribution of events caused by various groups of excavation equipment. In 2018 the Hoe/Trencher group continues to account for the largest volume of events, despite a significant drop in overall incidents. Efforts should be made by reporting groups to minimize listing equipment as “Other” in order to improve the accuracy of data.

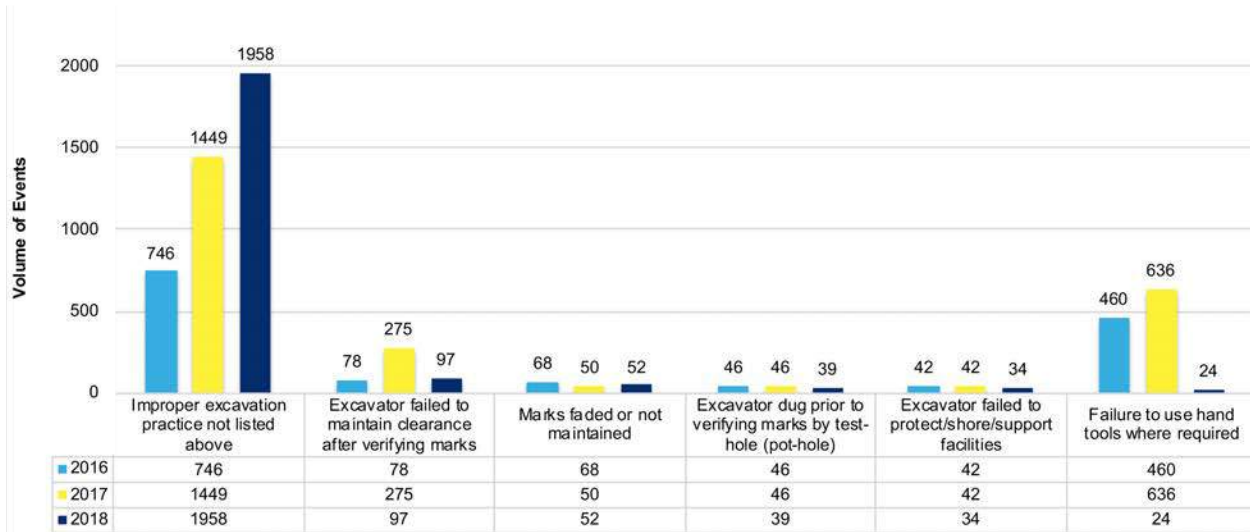
**Figure 9: Facility Events by Excavation Practices Not Sufficient**

Figure 9 illustrates a breakdown of the Root Cause subcategories for Excavation Practices Not Sufficient. As seen below, Improper Excavation Practice Not Listed Above has seen a dramatic increase over the previous year. This Root Cause subcategory is defined as any other excavator error, which cannot be classified as one of the other six Root Cause subcategories within Excavation Practices Not Sufficient.

The next highest Root Cause subcategory is the failure to maintain clearance.

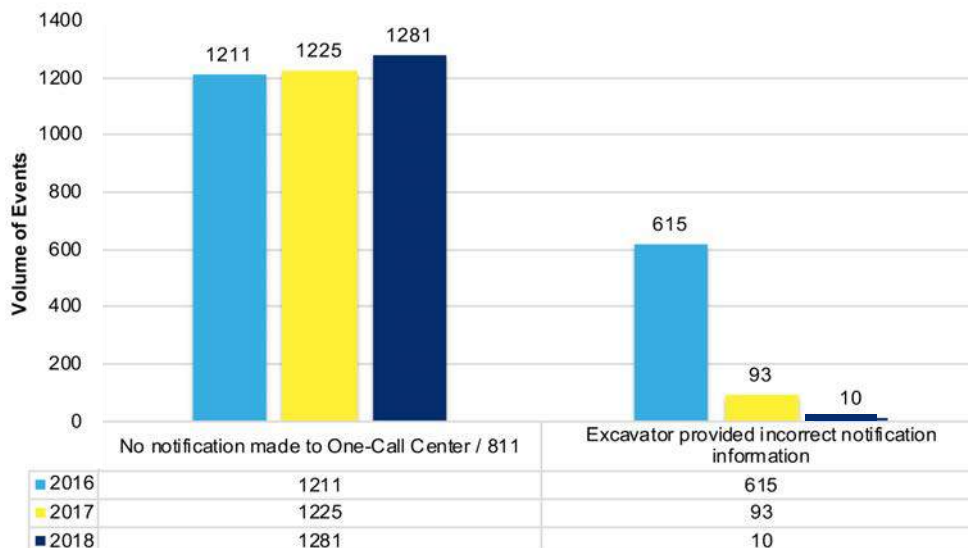
**Figure 10: Facility Events by Notification Issues**

Figure 10 illustrates a breakdown of the Root Cause subcategories for Notification Issues for the past three years. This figure illustrates the need to continuously increase excavator and general public awareness about calling to request a locate before digging starts.

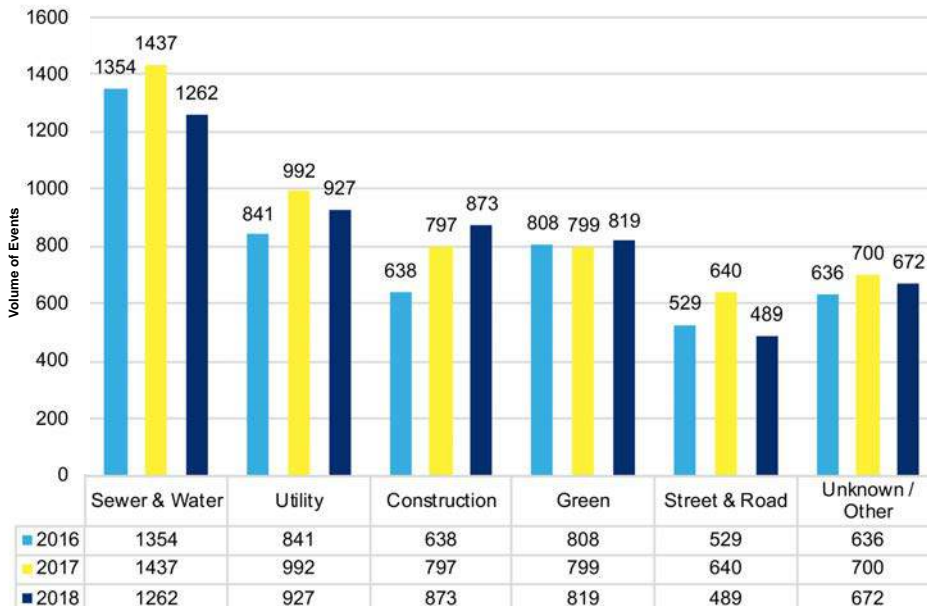
**Figure 14: Facility Events by Type of Work Performed**

Figure 14 illustrates a distribution of Events by Type of Work Performed. Sewer & Water continues to be involved in the majority of the events submitted, but has seen a significant decrease from 2017. Also, of concern is Construction which has shown an increase three years in a row. Those who are responsible for submitting events should strive to reduce the amount listed as Unknown/Other in order to improve data completeness and accuracy.

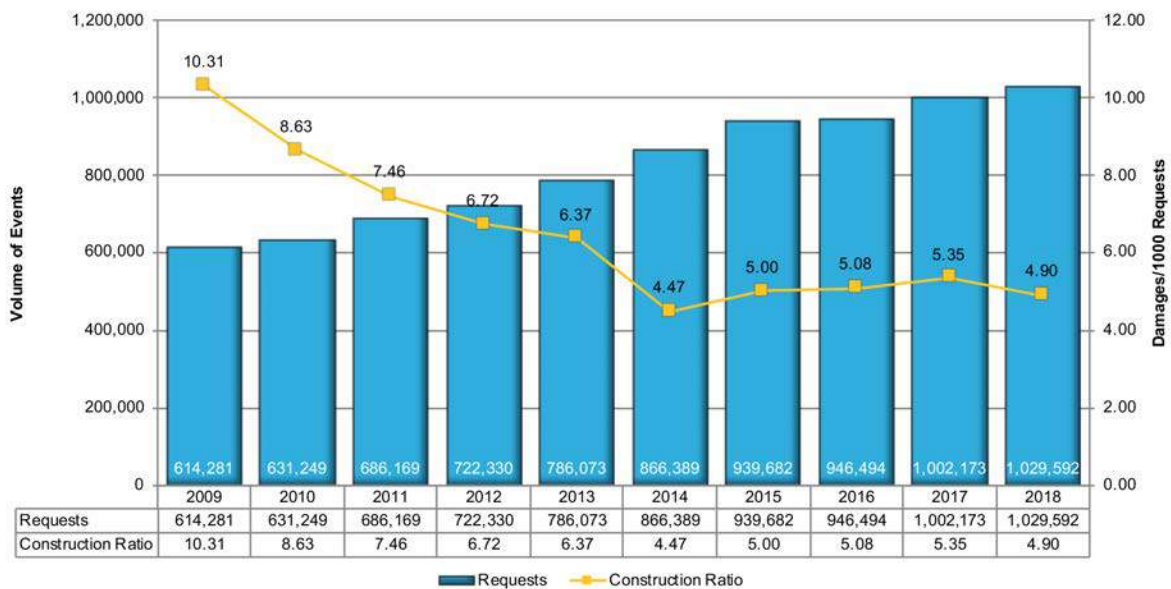
**Figure 18: Request Ratio**

In response to the Ontario One Call changes, this chart was created to show damages per 1000 requests as this has remained consistent and is driven by either public awareness or economic events.

The 2018 Damage to Request Ratio shows a decrease reversing an upward trend from 2014. This appears to disagree with Figure 17, however as explained there, this is due to a process change at the One Call Centre.

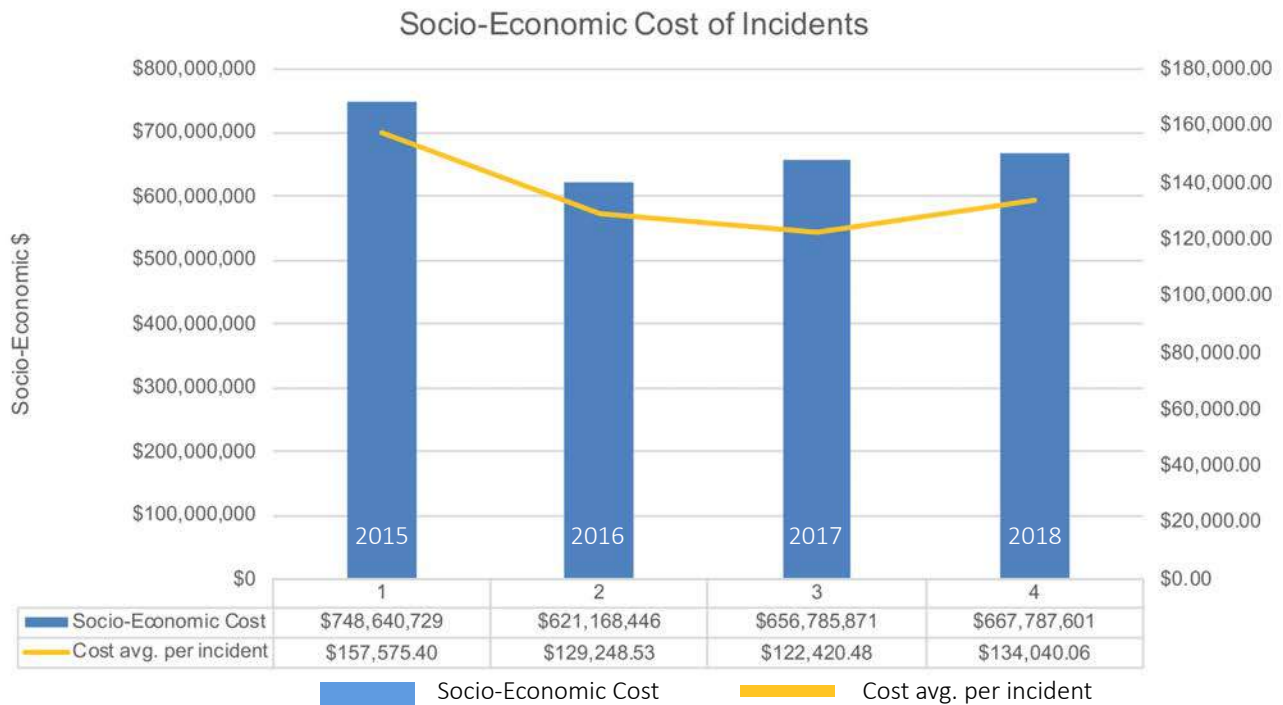
**Fig 21 Socio-Economic Cost of Incidents**

As seen in the chart (Fig. 21) below, as of this point there is no discernable trend in the four years of data we have. Also as of this point and time, we have no breakout of what infrastructure was damaged. This limits our ability try to peer deeper and see if the variation in the average cost per incident is related to the distribution of the damages between the different Stakeholders.
